River Pisuerga Railway Bridge repair project

Villaescusa de las Torres, Spain / 2012

Owner

ADIF

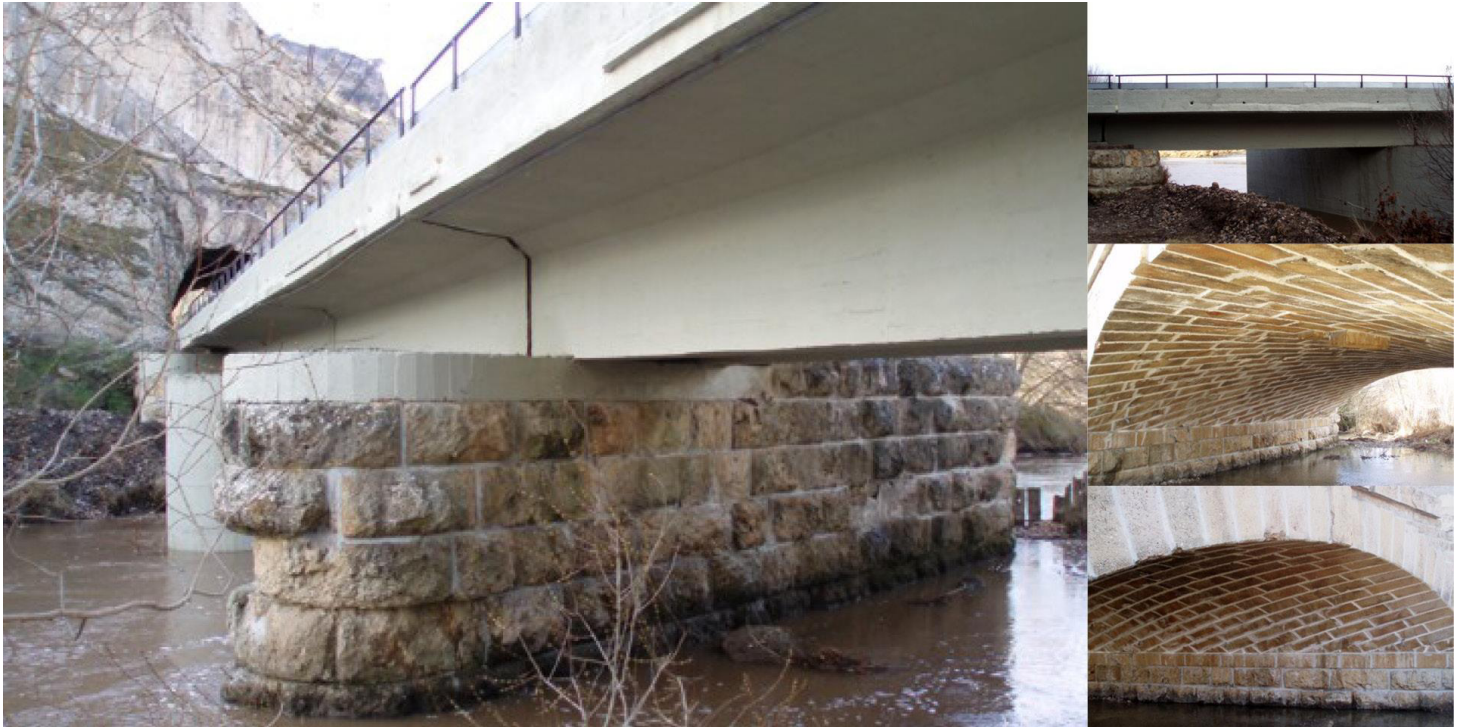
The interventions which took place have been on one hand the construction of a cantilevered service lane on the side of the bridge and on the other the operations of cleaning and structural rehabilitation.

These operations included the cleaning up and repair of the concrete facing and the subsequent application of anti-carbonation paint.

The arch masonrywork was repointed and then injected with grout for consolidation.

Improvements were made in drainage including spills, weep holes and sealing of joints between deck slabs.
