Repair works on the railway bridge in Cala de Agudulce

Sitges, Spain / 2012

Structural type
Client

four brick-construction vaults set on stone masonry piers
ADIF

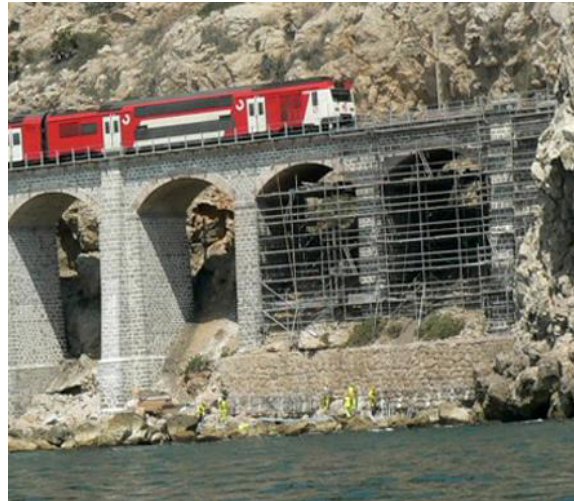
The Works fulfilled can be broken down into three clearly different operations. The first consists of the construction of a service way which is built on the side of the bridge in cantilever. The second is the general operations of cleaning and structural rehabilitation, consisting in high-pressure cleaning of the face and recomposition and re-pointing of the masonrywork. Thirdly and finally, the protection of the foundations and one of the abutments by placement of a perimeter trench filled with reinforced concrete, employing galvanized steel bars.
