# Palma del Río bridge repair

Lora del Río, Seville, Spain / 2021

Consejería de Fomento, Infraestructuras y Ordenación del Territorio de la Junta de Andalucía  
rehabilitation project and technical support

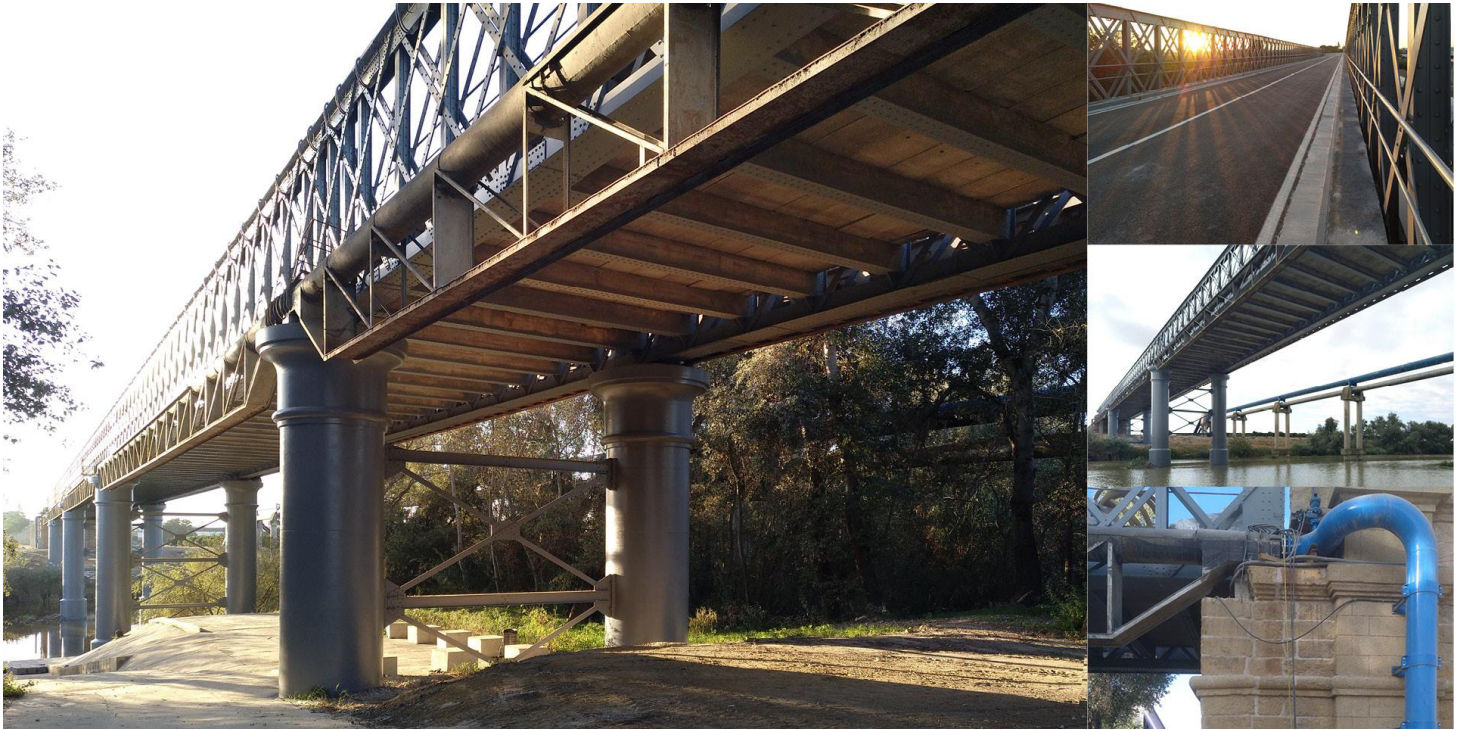
During routine inspections, severe damages were observed in the abutments, linked to blocked rolling steel bearings and partial disintegration of its masonry ashlar pieces.

Rehabilitation works have comprised steel bearing rehabilitation or renovation, masonry abutment strengthening, masonry pointing, repainting, and drainage improvement.
